Powerdynamo brings new ignition & light to your vintage motorcycle

problems with different versions of camshafts in BMW R69, 69S and 68

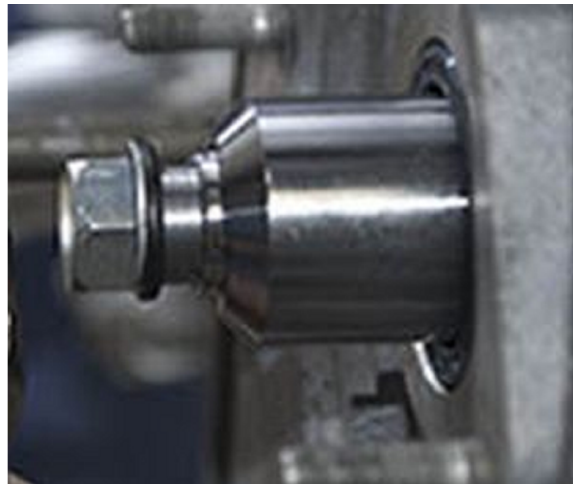
Most BMW so far for which we delivered our System 70 80 999 or System 70 81 999 had the short cam and assembly of the cam-pieces looks as shown in the picture here.

The standard cam-piece reaches into the oilseal.

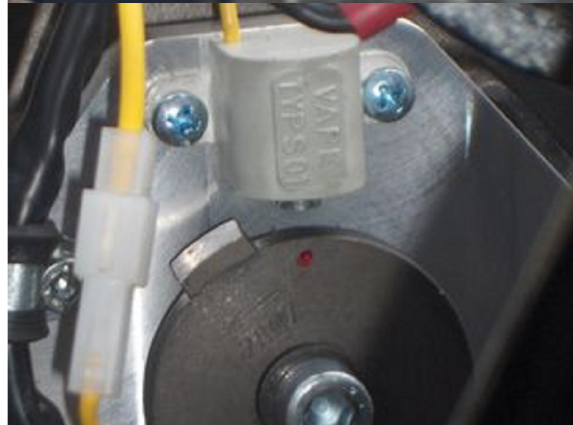
And the trigger disc (in modells 70 80 999) is positioned correctly against the sensor as shown here.

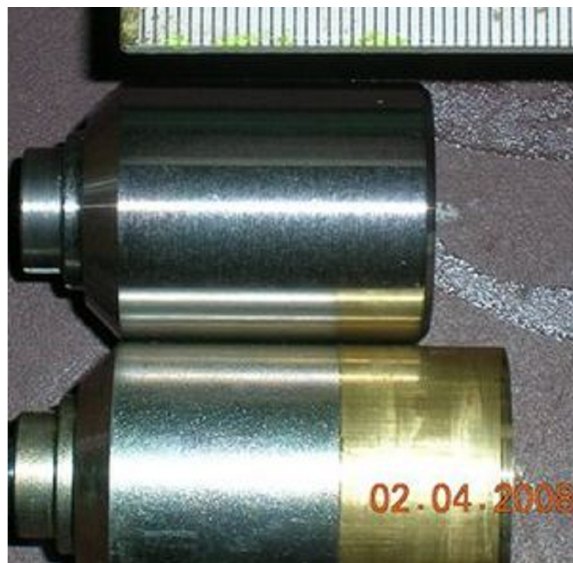
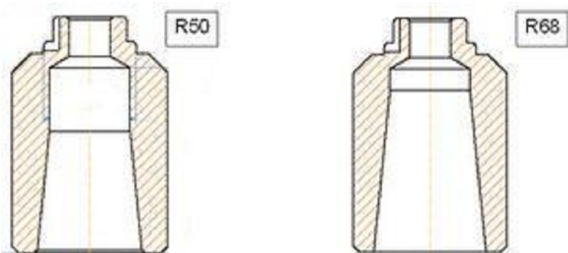
In most cases where there was an R68 cam in the engine, the standard cam-piece does not reach into the oilseal. It ends shortly before it.

Here we first made some prolongation of the cam-pieces as shown in photo and later modified entry diameter of the standard piece to allow it to sit lower. See sketch below

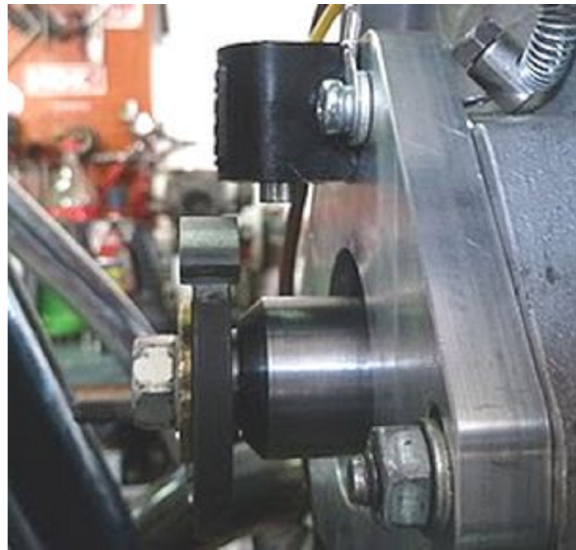
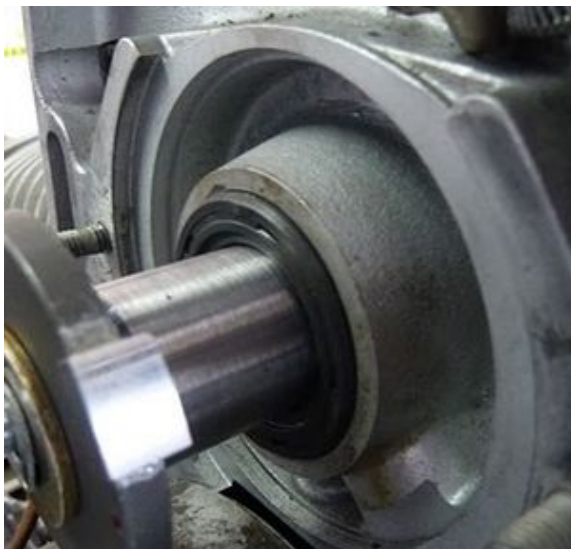
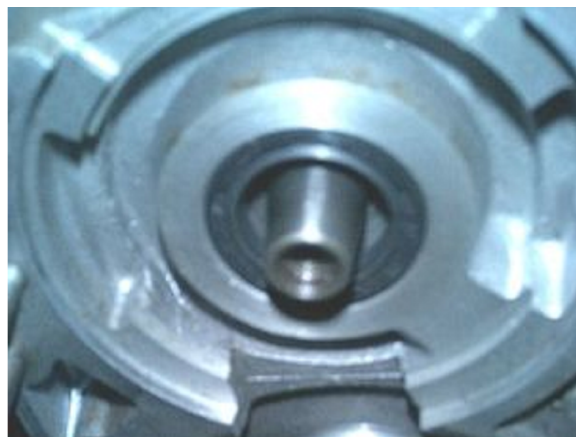
But, we have also got cases where the standard cam-piece reaches into the oilseal but the trigger disc is lying beyond the sensor by some 15mm (hence not enabling any ignition pulse)

What is visible in those cases is that the engine housing of the engines concerned looks different in the camshaft area (see photos below)

here solution should be to place a spacer block of 15mm thickness under the sensor.

In case of doubt better ask for system 70 81 (crankshaft triggered system), than at least the problem of the trigger disc can not happen.
